Bulletin No.: 05-08-64-002B

Subject: Door Latch Freezing in Cold Temperatures (Apply Super Lube)

**Models: 2005-2007 GM Passenger Cars and Trucks (Including Saturn)
2003-2006 HUMMER H2
2006 HUMMER H3**

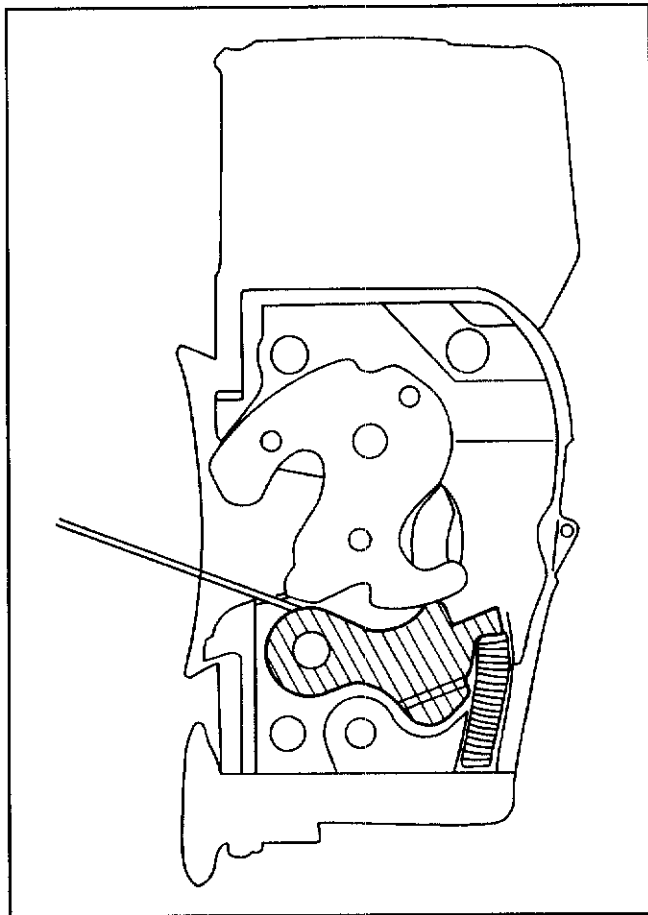
1580414

Important: The latch and its backing plate have been removed on the above illustration to show the location for the lube.

2. Allow the latch to completely thaw and apply compressed air for two seconds to the latch to force out any moisture. Refer to the above illustration (slashed area) for the location. Spray GM Super Lube® on BOTH sides of the latch detent lever for approximately two to three seconds. Refer to the above illustration (slashed area) for the lube location. Repeat for all door latches. Operate the door latch several times to spread the lubricant on all surfaces.
